Dilapidation Report

Pre-Construction

PROPERTY: XX XXX Crescent
XXXXX Heights

JOB NUMBER: 222-0595-XXX-XX

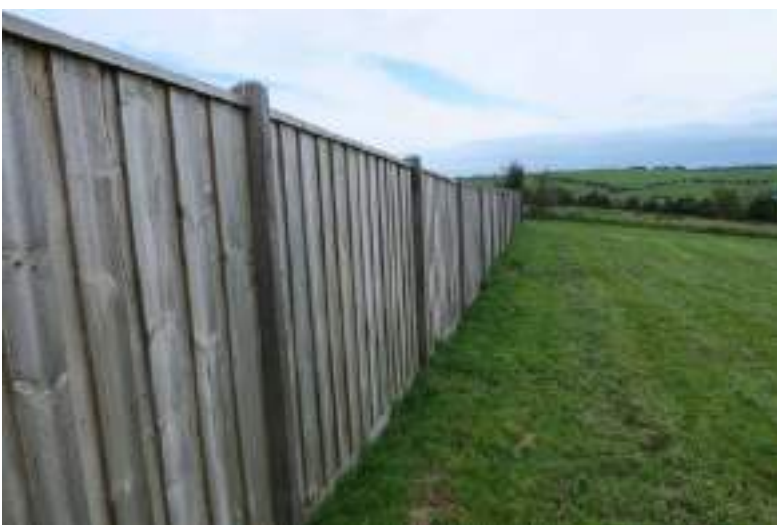
IMG_9115.JPG

View to fence NW of house.
Fence dips slightly.

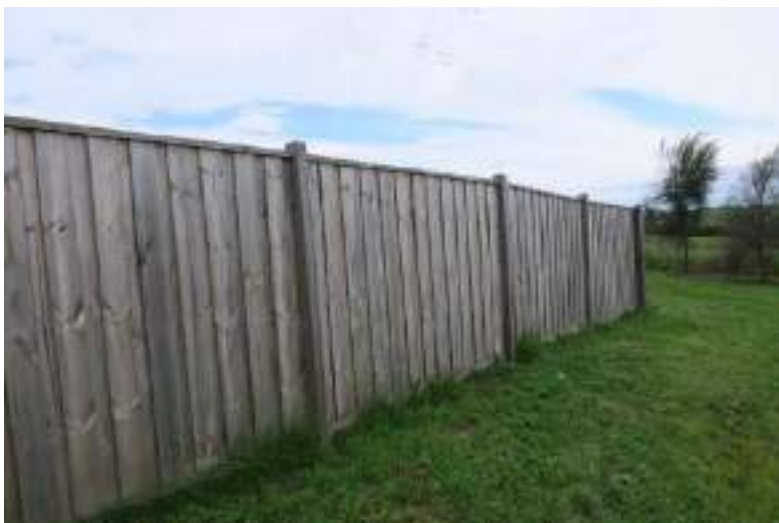
IMG_9117.JPG

View to fence west of last.
Note soil gap between bottom of
fence/ground level over 2 panels.

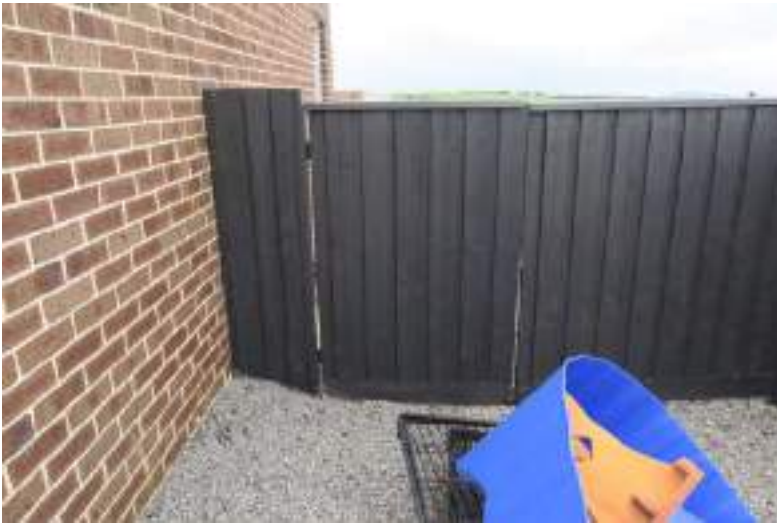
IMG_9129.JPG

View to side gate at top of gate.
Gate leans on fence.

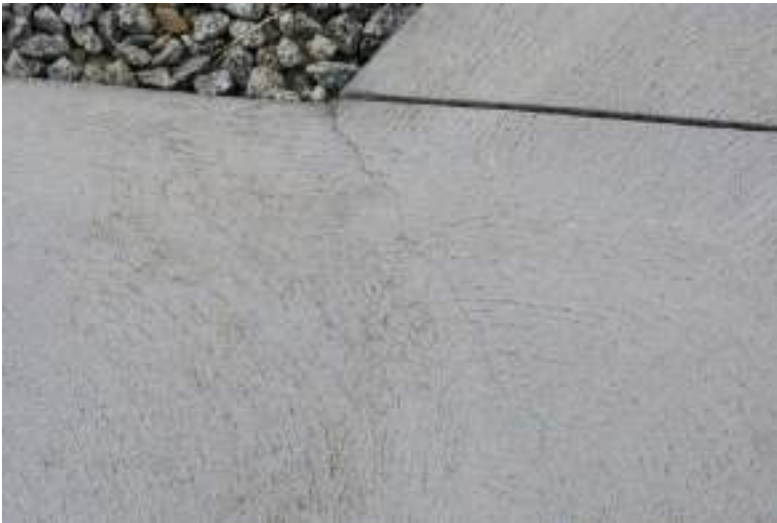
IMG_9134.JPG

View to driveway NE of front entry brick pier.

Hairline crack, extends west approx. 400mm.

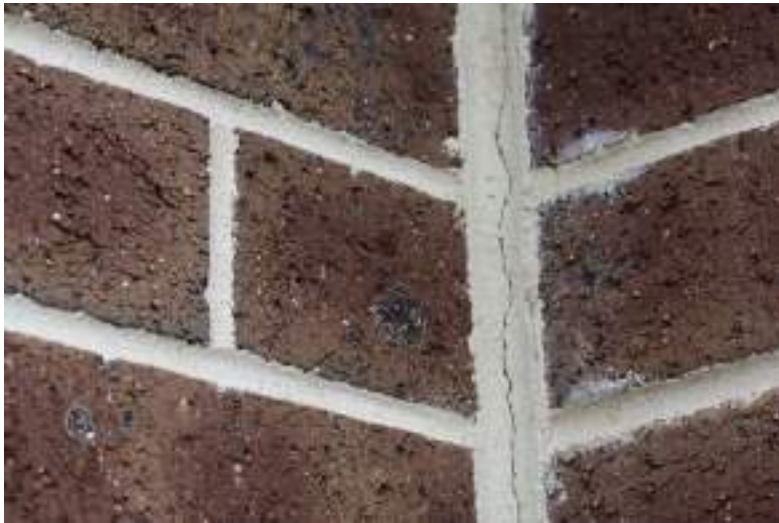
IMG_9137.JPG

View to house on SE corner at ground level.

Hairline crack to vertical joint.

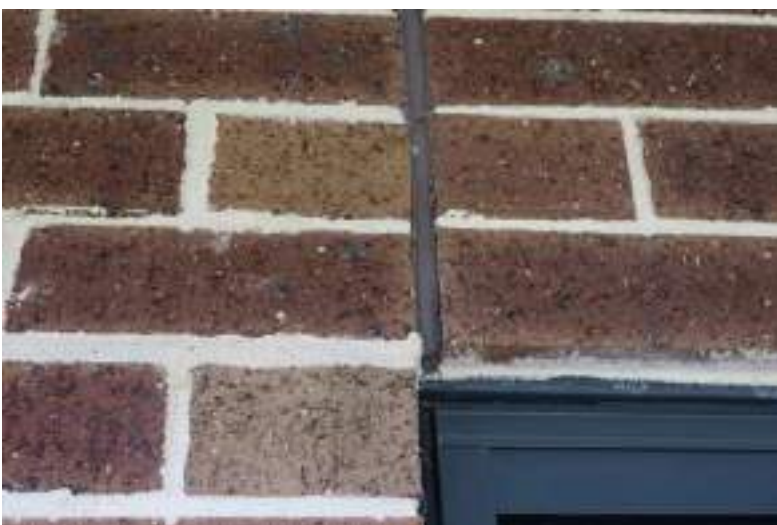
IMG_9142.JPG

View to brickwork top left of sliding doors
to house.

Light shrinkage of vertical caulking joint.

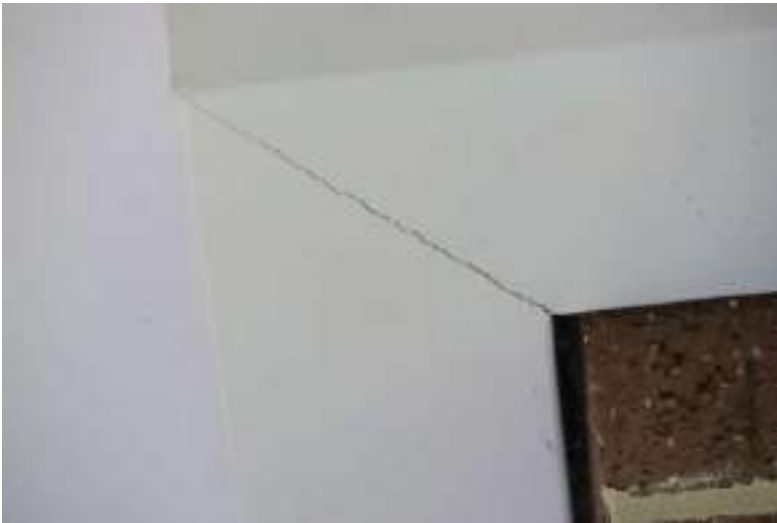
IMG_9143.JPG

View to cornice in NW corner.

Hairline separation of cornice mitre. Similar in SW corner.

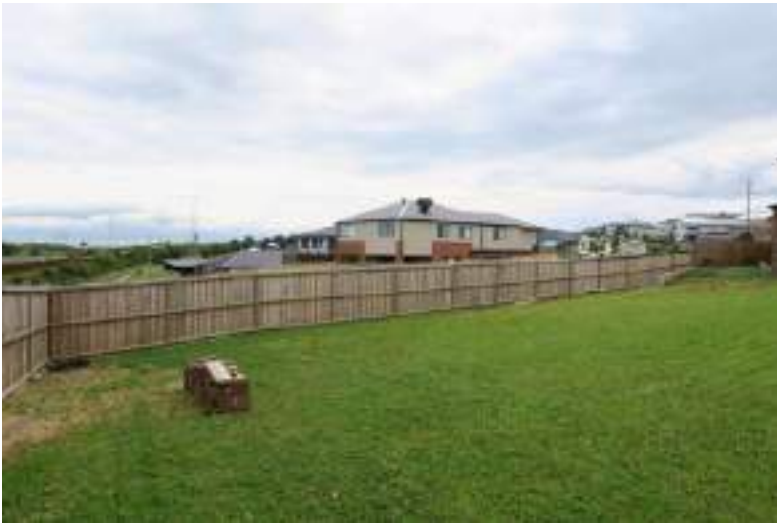
IMG_9148.JPG

View to fence post 4 west of north retaining wall.
Vertical split to timber post.

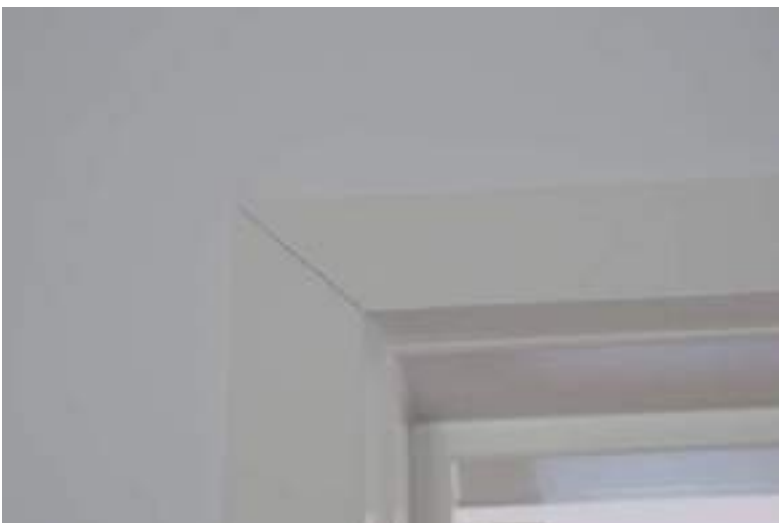
IMG_9156.JPG

View to architrave top left of door to living room.

Hairline separation of architrave mitre.

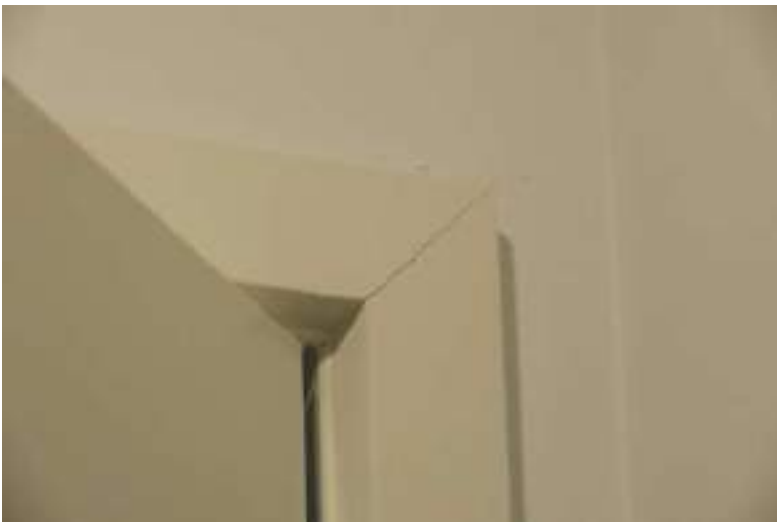
IMG_9158.JPG

View to architrave top right of door to front entry corridor.

Hairline separation of architrave mitre.
Similar elsewhere.

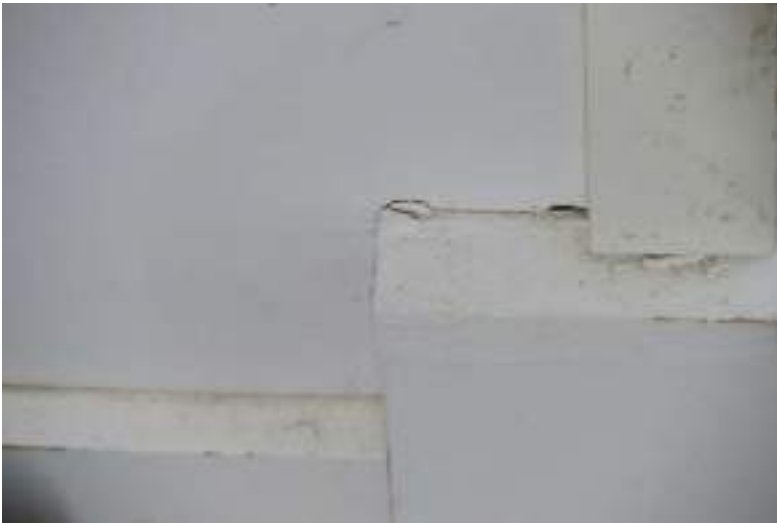
IMG_9160.JPG

View to skirting bottom left of door to house.

Hairline separation of skirting/wall.

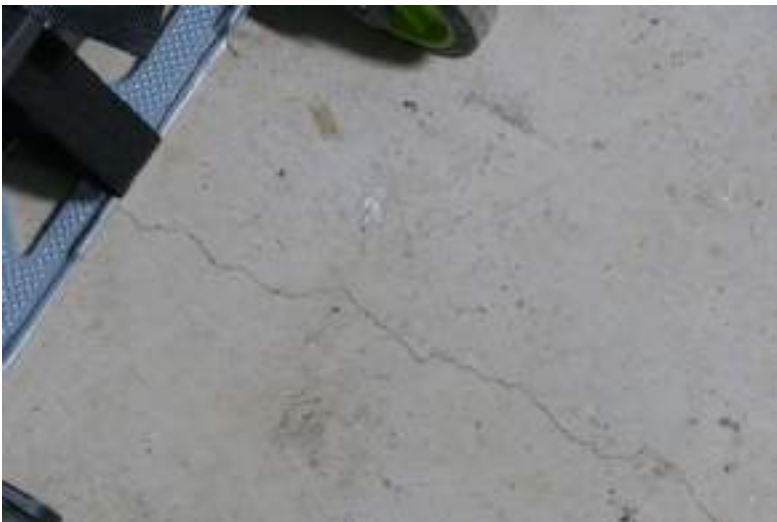
IMG_9161.JPG

View to concrete slab south of centre.

Hairline crack to concrete, extends north-south. Extent obscured by parked vehicle.

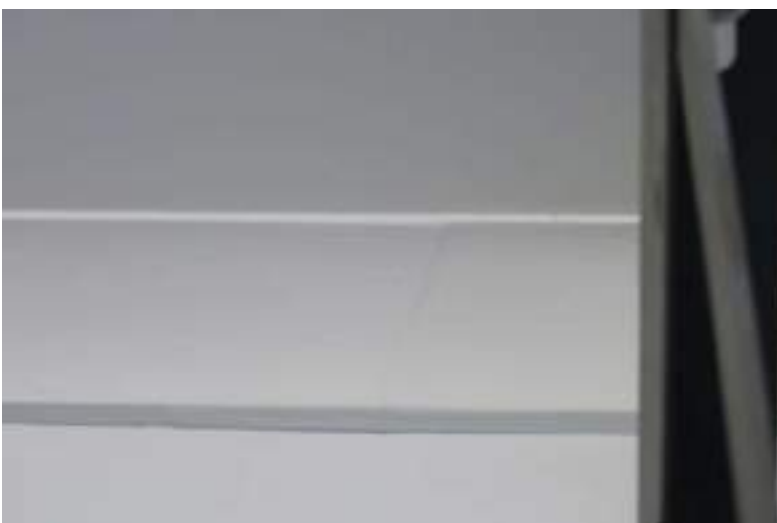
IMG_9162.JPG

View to cornice top left of west roller door.

Hairline separation of cornice joint.

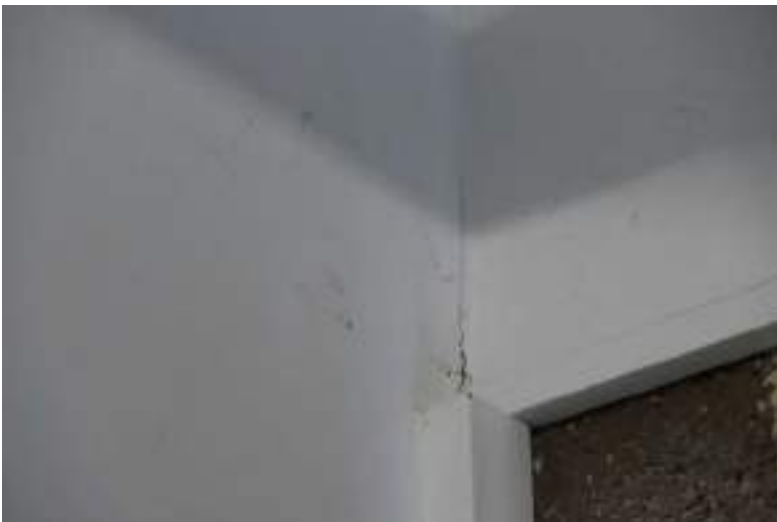
IMG_9164.JPG

View to wall in top NE corner.
Hairline crack to wall, extends up from timber batten approx. 80mm.

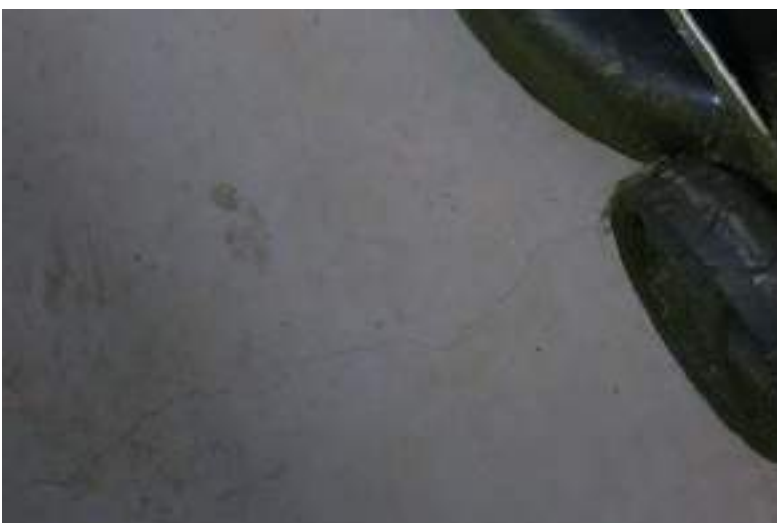
IMG_9165.JPG

View to north edge of slab below GPO.
Hairline crack, extends south. Possibly connects to previously noted hairline crack.

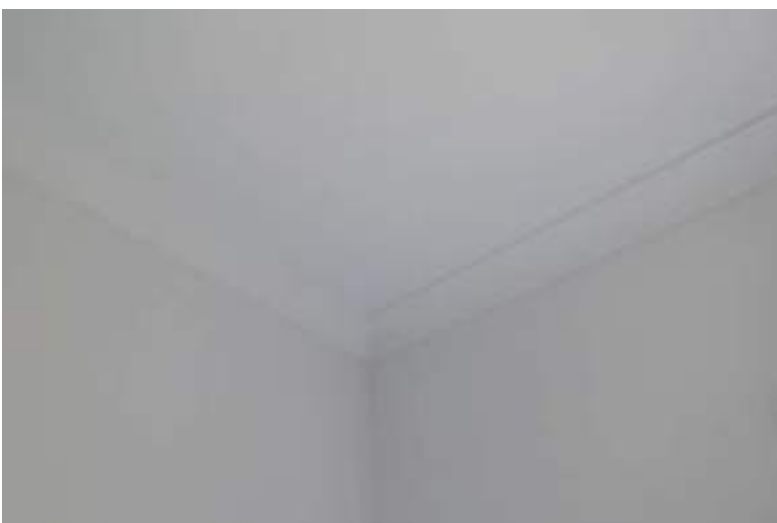
IMG_9167.JPG

View to architrave top left of RH north window.

Hairline separation of architrave mitre.

Similar elsewhere.

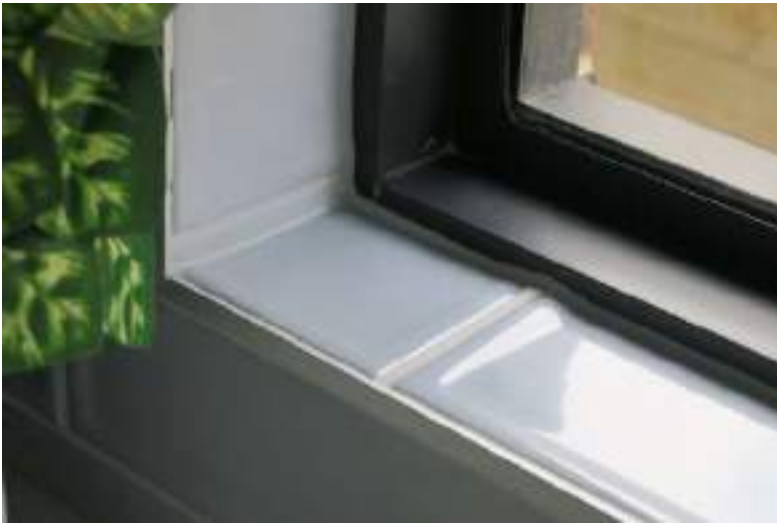
IMG_9171.JPG

View to sill bottom left of RH west window.
Hairline crack to paint over approx. 60mm.

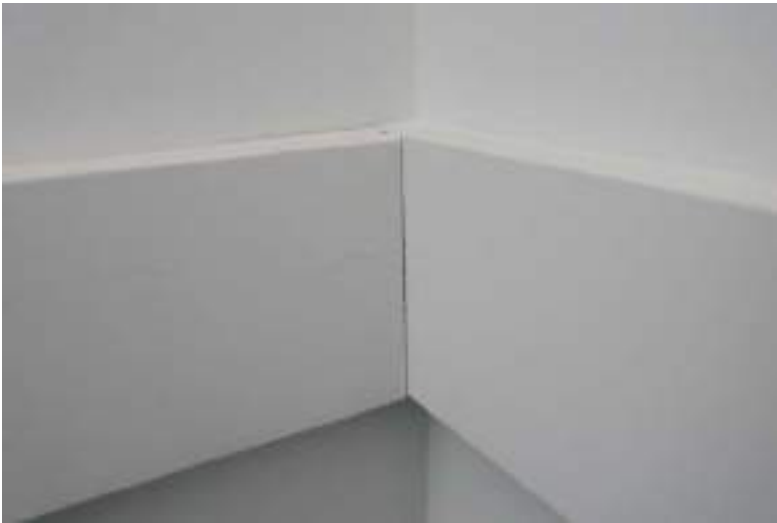
IMG_9175.JPG

View to timber band above SE corner of staircase.

Hairline separation of joint. Similar in SW corner. See additional photo.

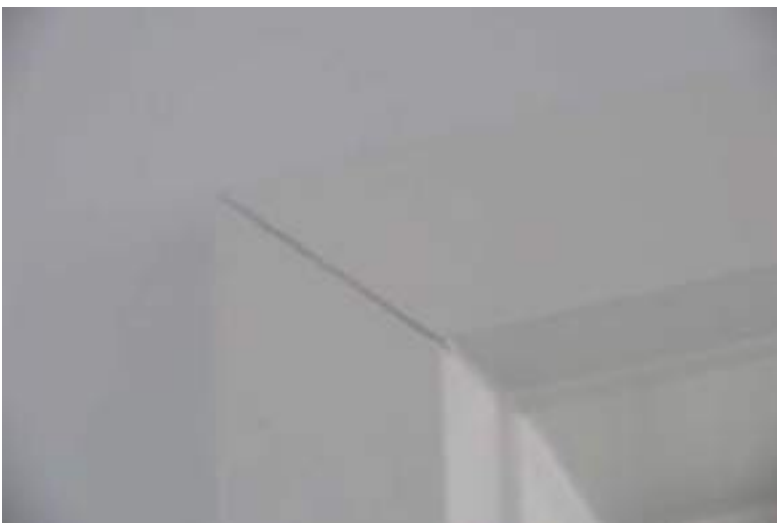
IMG_9176.JPG

View to top stair at balustrade.
Hairline separation of post/tread.

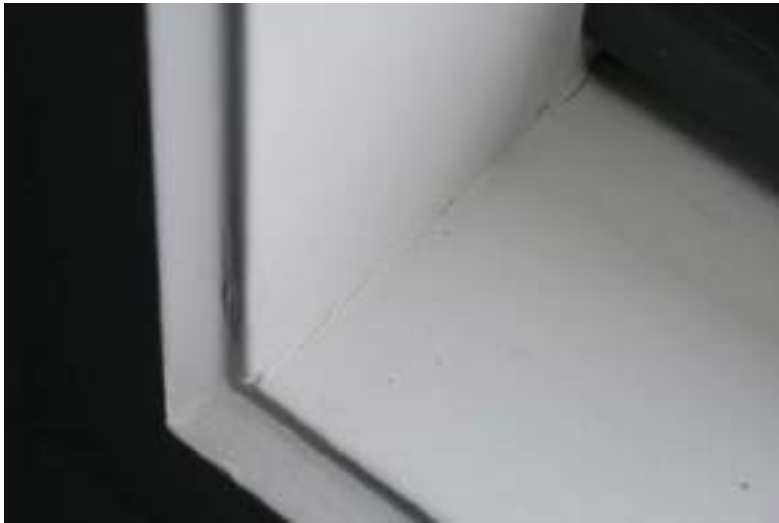
IMG_9177.JPG

**INTERIOR LEVEL 1
LANDING**
**View to architrave top left of door to east
bedroom.**
Hairline separation of architrave mitre.

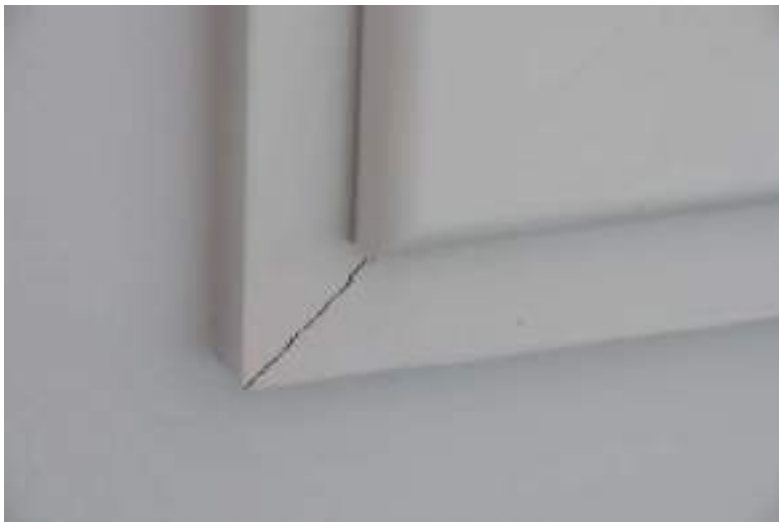
IMG_9187.JPG

View to skirting in NE corner.
Hairline separation of skirting mitre.
