Dilapidation Report

Pre-Construction

PROPERTY: XX XXX Crescent
XXXXX Heights

JOB NUMBER: 222-0595-XXX-XX

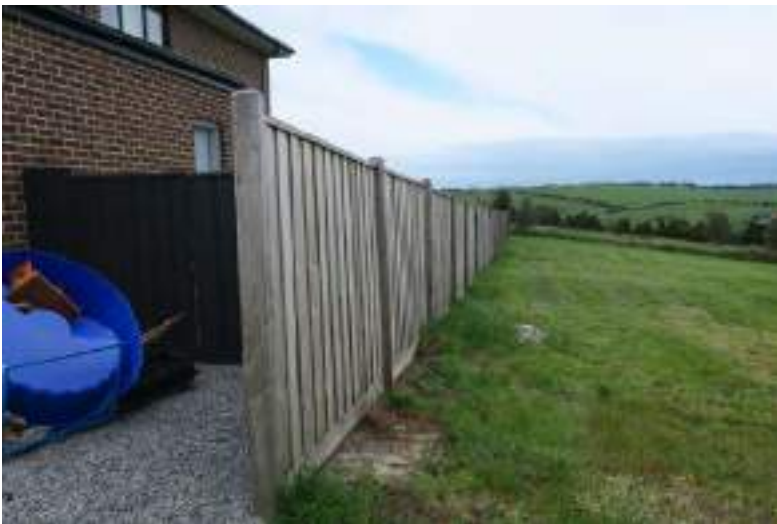
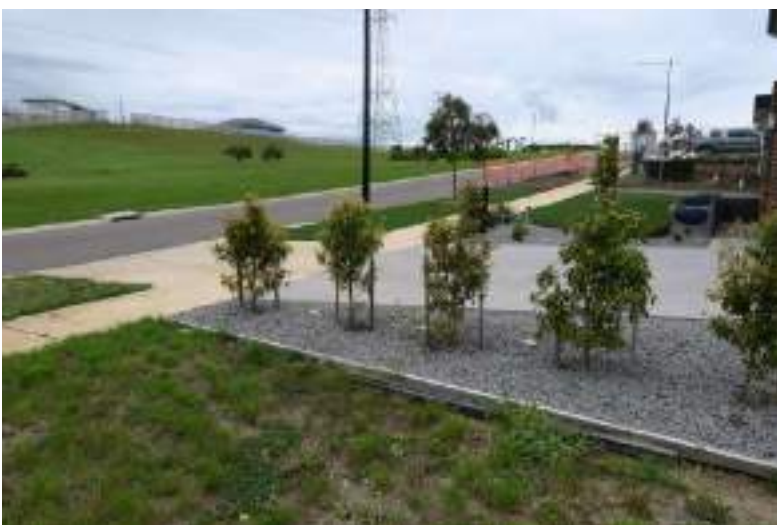
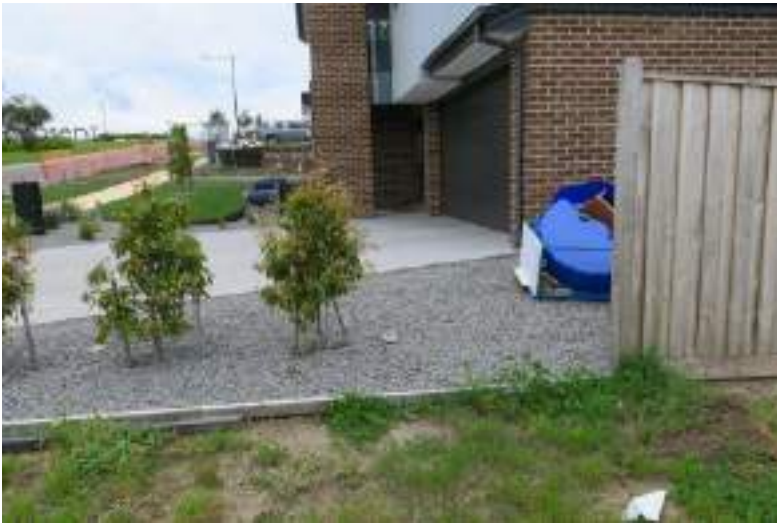
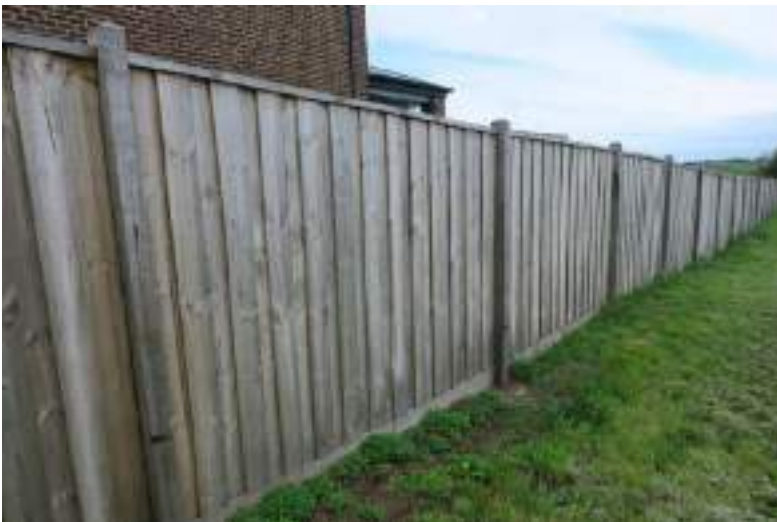
IMG_9111.JPG

**EXTERIOR
NORTH ELEVATION FROM SITE**

View to fence along boundary.
Overall photo for reference. See additional photos.

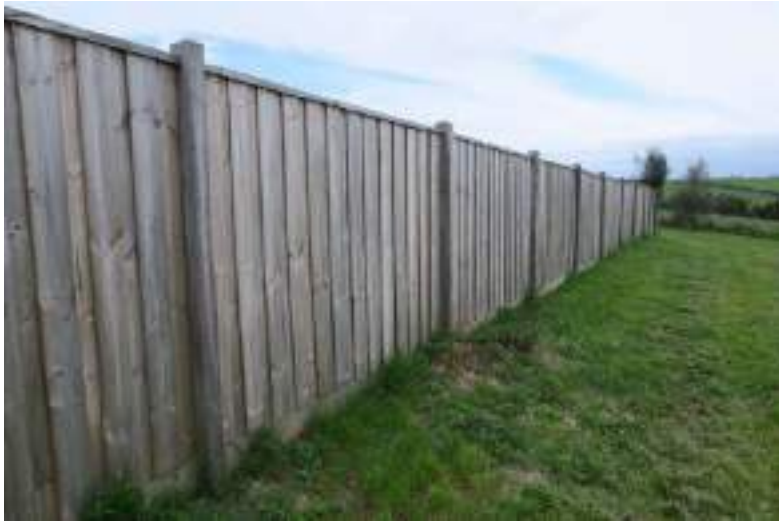
IMG_9116.JPG

View to fence west of last.
Overall photo for reference.

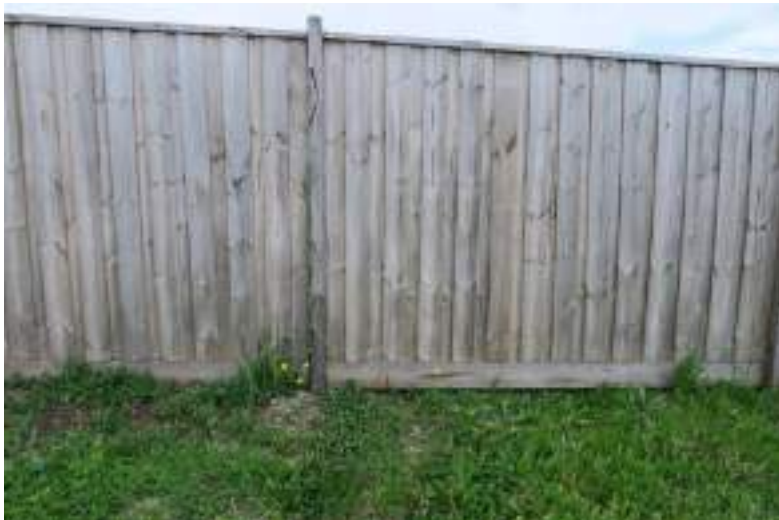
IMG_9117.JPG

View to fence west of last.
Note soil gap between bottom of
fence/ground level over 2 panels.

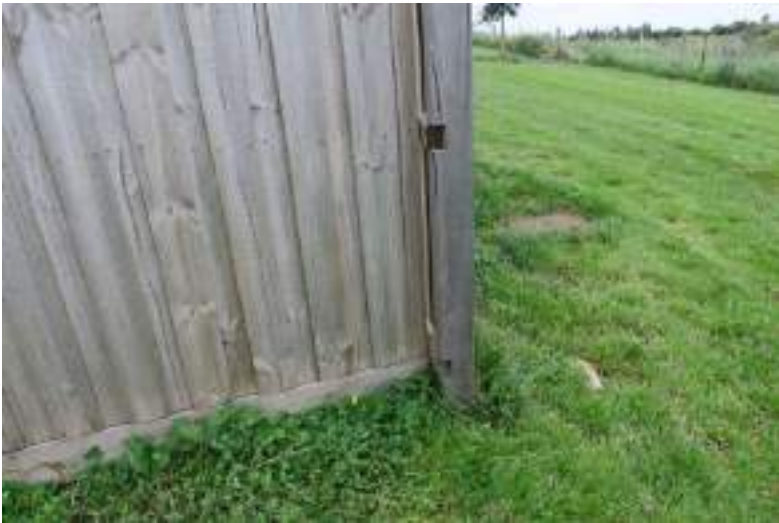
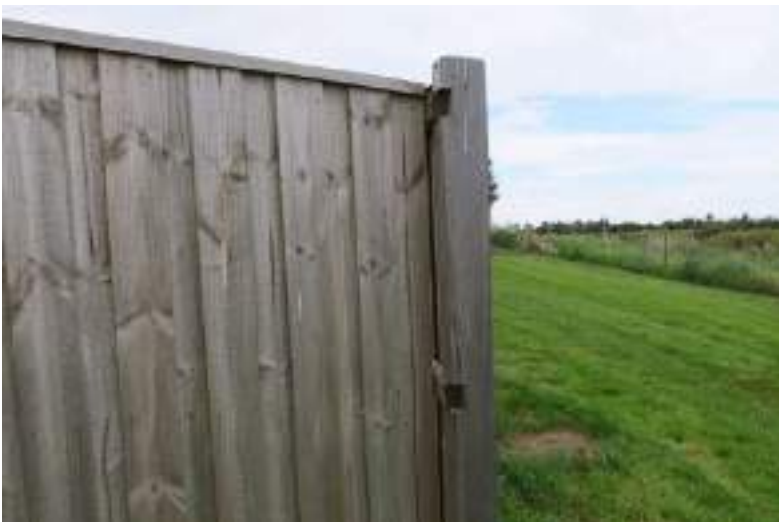
IMG_9119.JPG

View to fence on NW corner of property.
Overall photo for reference. See additional photo.

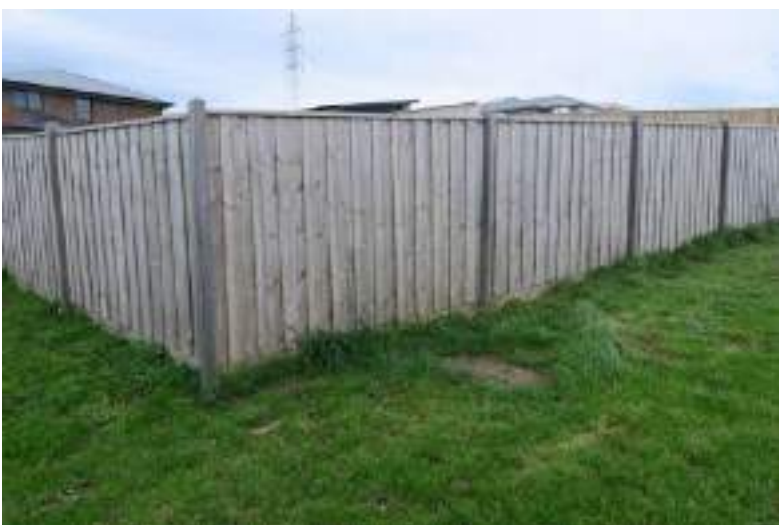
IMG_9121.JPG

View to fence on west end of property.
Overall photo for reference. See additional photo.

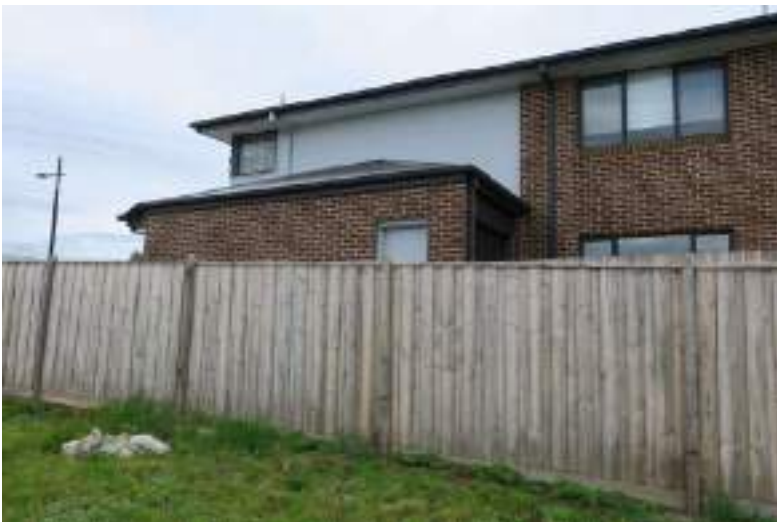
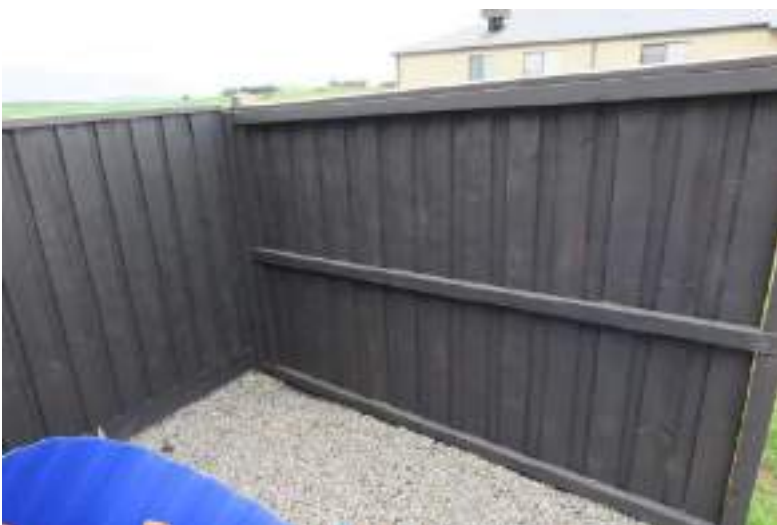
IMG_9127.JPG

View to side fence north of garage.

Overall photo for reference. See additional photo.

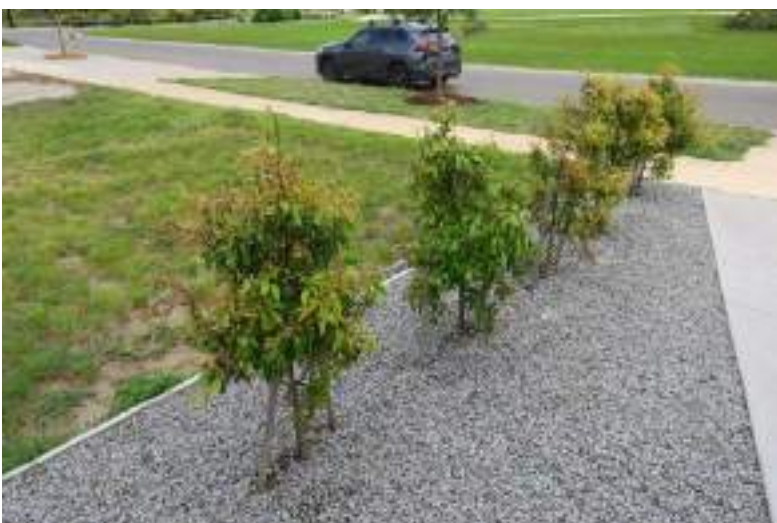
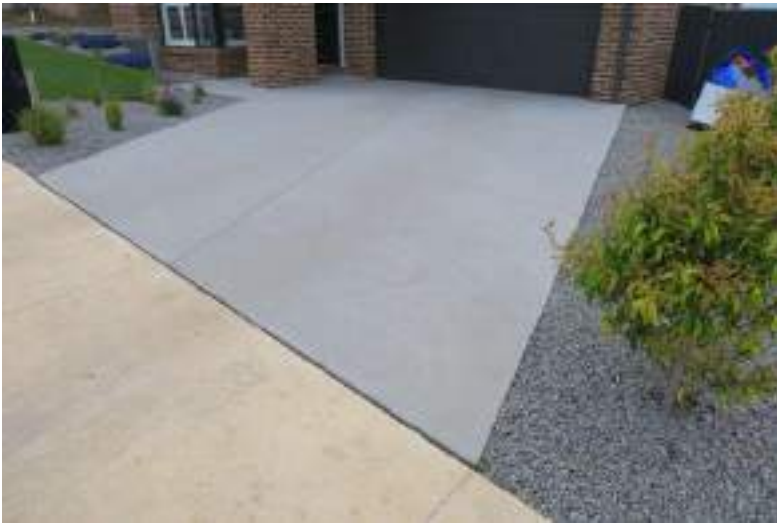
IMG_9131.JPG

View to driveway.

Overall photo for reference. No visible cracking.

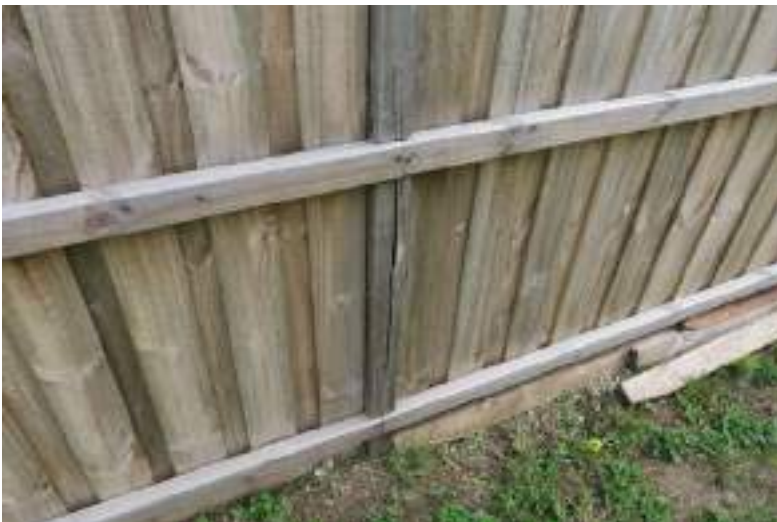
IMG_9148.JPG

View to fence post 4 west of north retaining wall.
Vertical split to timber post.

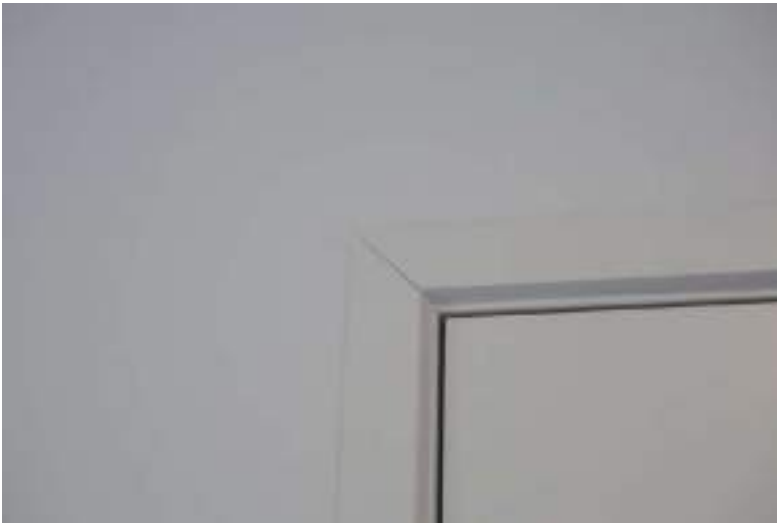
IMG_9166.JPG

LIVING/DINING

View to architrave top left of door to front entry corridor.

Hairline separation of architrave mitre.

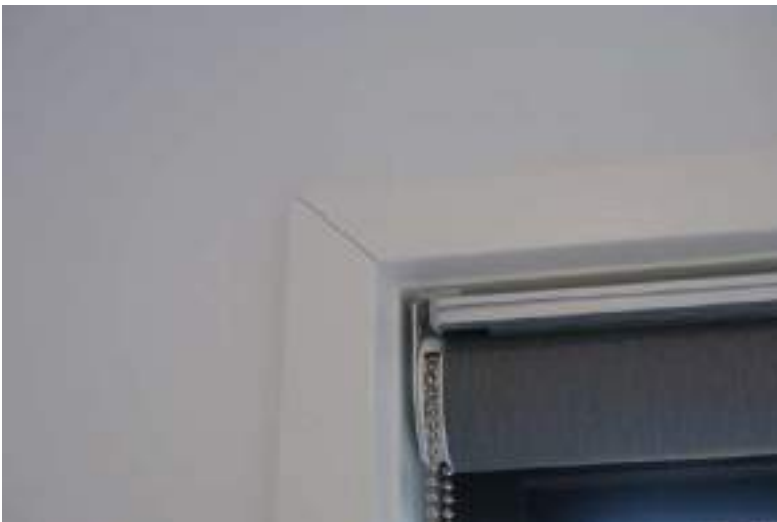
IMG_9167.JPG

View to architrave top left of RH north window.

Hairline separation of architrave mitre.

Similar elsewhere.

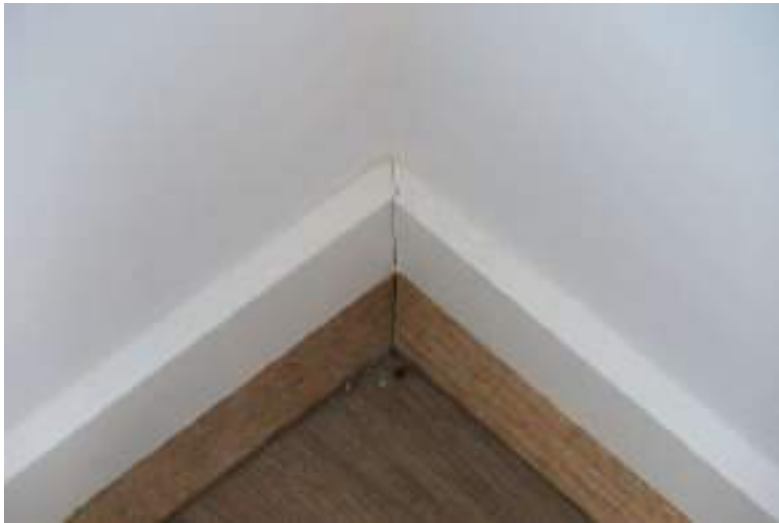
IMG_9169.JPG

View to skirting in NW corner.
Hairline separation of skirting mitre.

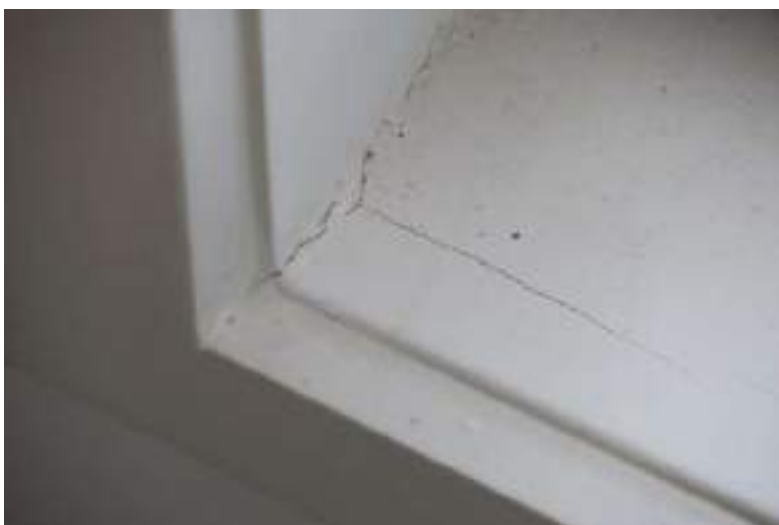
IMG_9171.JPG

View to sill bottom left of RH west window.
Hairline crack to paint over approx. 60mm.

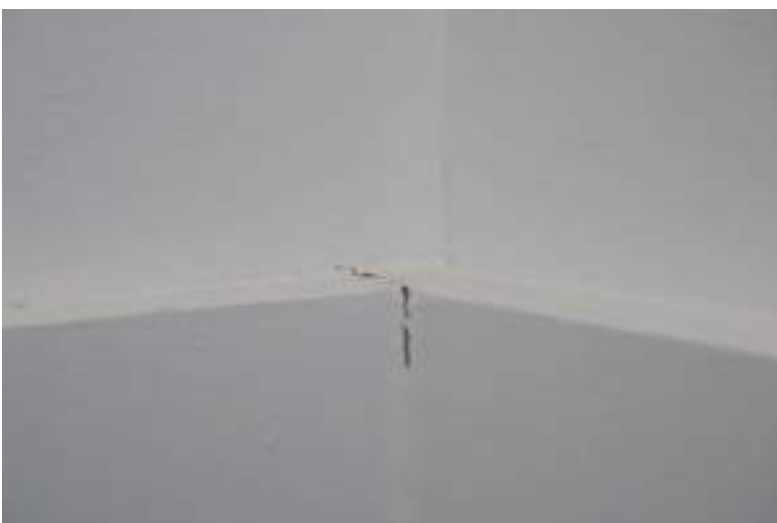
IMG_9174.JPG

GROUND LEVEL TO LEVEL 1 STAIRCASE

View to timber band above SE corner of staircase.

Hairline separation of joint. Similar in SW corner. See additional photo.

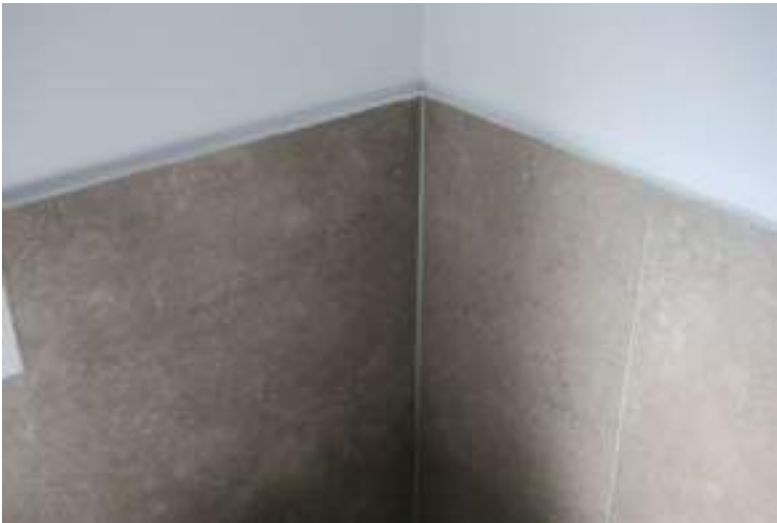
IMG_9181.JPG

BATHROOM

View to wall tiles in SW corner.

Photo for reference. No visible cracking to tiles or grout joints.

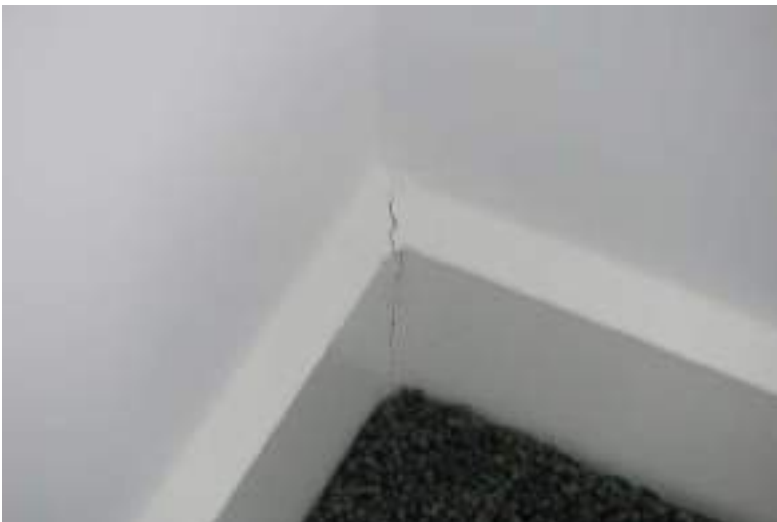
IMG_9182.JPG

SW BEDROOM

View to skirting in NE corner.

Hairline separation of skirting mitre. Similar elsewhere.

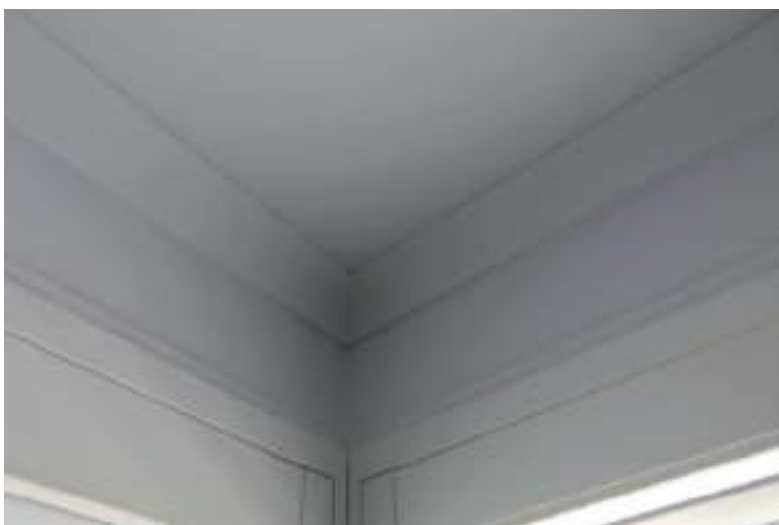
IMG_9186.JPG

View to wall/ceiling in NE corner.

Photo for reference. No visible defect.

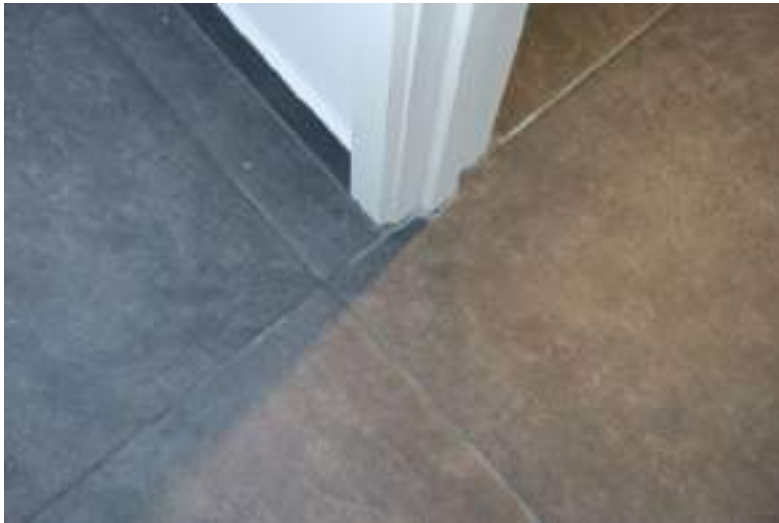
IMG_9190.JPG

View to floor tiles bottom left of door to ensuite toilet.

Photo for reference. No visible cracking to tiles or grout joints.

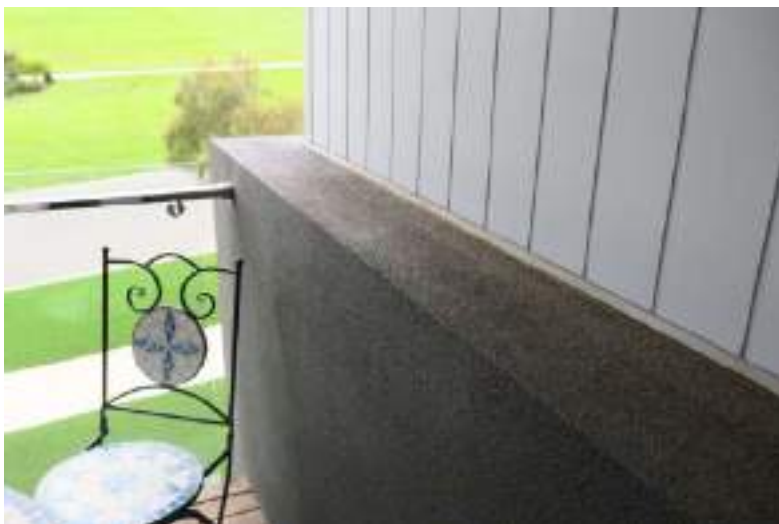
IMG_9191.JPG

**EXTERIOR
EAST BALCONY**

View to render on south elevation.

Photo for reference. No visible defect.

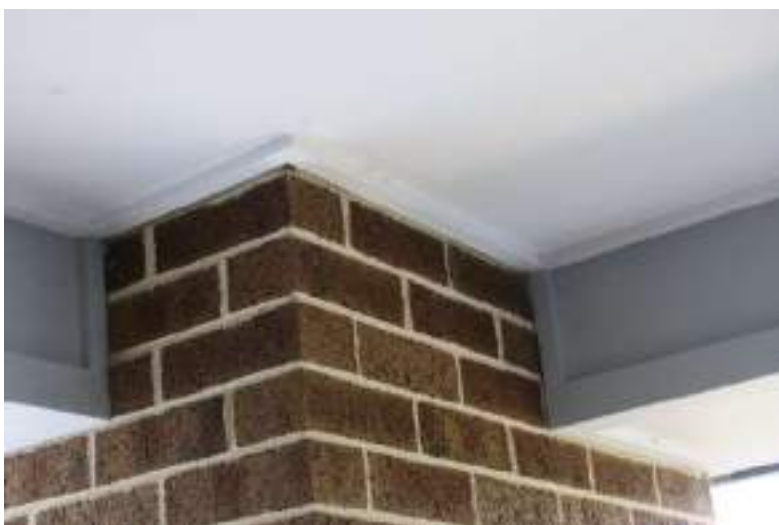
IMG_9192.JPG

View to balcony ceiling in NE corner.
